## TESTING THE REPLACEMENT OF TOTAL AND MOBIL PLASTIC LUBRICANTS WITH MAPU-1 AND MAKN-2 LUBRICANTS

**Abstract:** Solution of the replacement of plastic lubricants of the Mobil-NLGI 00 type (to the PSU-planetary directional device) and Total-NLGI 0 (to the KP-final gear) for the MAPU-1 (in PSU) and MAKN-2 (in KP) lubricants. The design of plastic lubricants was performed in cooperation with Armed Forces Academy of General Milan Rastislav Štefánik represented by Ing. Miroslav Marko, PhD. and CMAŠ ZZ II Žilina, represented by Ing. Stanislav Kolomazník within the Project VV-1/2018 to 2020. Testing of PM (plastic lubricants) was performed on a special vehicle type GM 578. After changing MAPU-1 and MAKN-2 lubricants for PM (NLGI 00 and 0) and running 197 km was carried out "1. Check collection". Further inspections will follow in the next period. On behalf of Armed Forces Academy of General Milan Rastislav Štefánik, Major was also actively involved in tribodiagnostics Ing. Vladimír Kadlub and Capt. Ing. Pavol Lukášik.

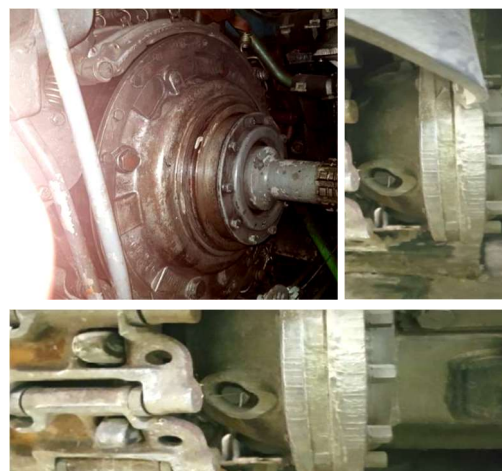
Fig. 3, 4, 5 Left PSU and right and bottom KP  
Source: authors.

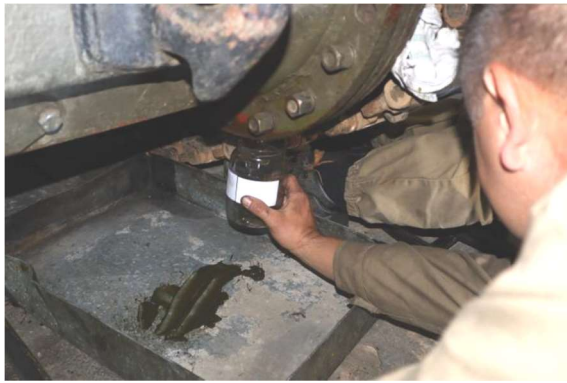
**Fig. 6** Sampling  
Source: authors.

Samples were taken from the RIGHT PSU and KP - The same PM, which was filled into the given machine nodes at the beginning of the test, was supplemented after sampling to the volume prescribed by the regulation for treatment in terms of technology for replacement and replenishment of PM.

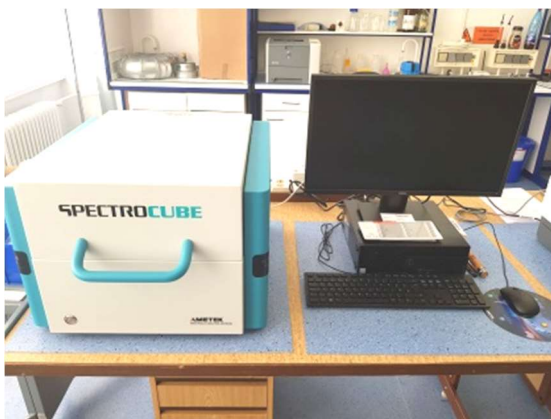
**Fig. 7** SpectroCUBE X-ray spectrometer  
Source: authors.

The SPECTRO CUBE ED-XRF analyzer is intended for screening for compliance with restricted elements. For each analysis, it displays the full spectrum of all relevant elements. Importantly, as the lists of restricted materials continue to grow, the user can activate new configurations so that they can work with other matrices, elements, and compounds in the future through simple software updates.

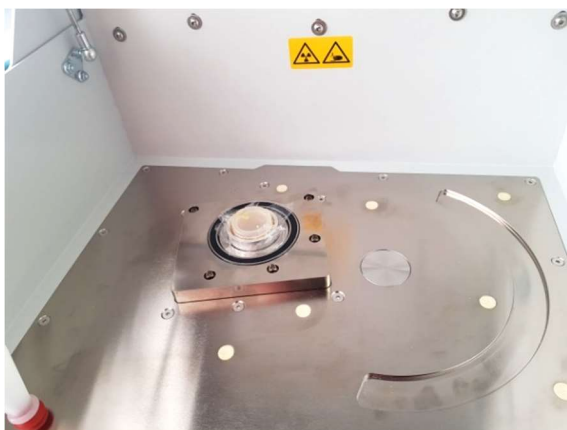
**Fig. 8** X-ray measuring part-Column  
Source: authors.

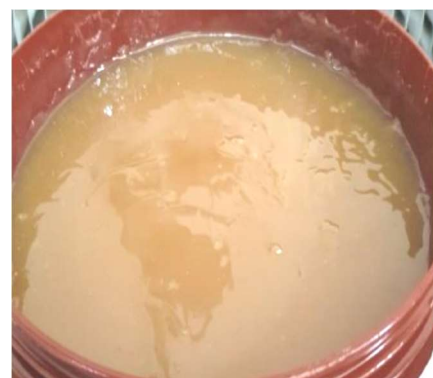
Visualization of PM Mobil Mobilux EP 004, NLGI 00, UNUSED, BEFORE the first test filling into the PSU:

**Fig. 10** PM Mobil Mobilux EP 004, NLGI 00, NEW  
Source: authors.

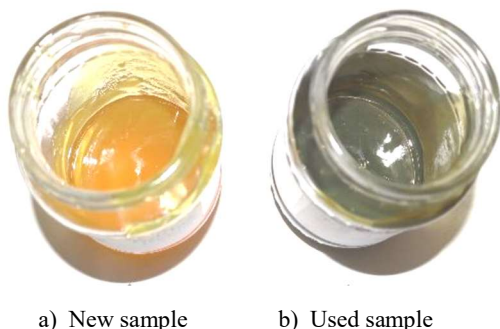
**Fig. 11** PM Mobil Mobilux EP 004, NLGI 00.  
Comparison of Reference and used sample  
Source: authors.

Comparison of samples of UNUSED PM and samples of USED PM: See a very slight darkening of used PM, which indicates a workload (PM was at a workload of 197 km / 292 days approximately from 21.11.2019 to 08.09.2020). PM is clear and visually shows no signs of sedimentation / separation of solid particles.

From the point of view of this test PM Mobil Mobilux EP 004, NLGI 00 SUITABLE for further use.

Comparison of samples of UNUSED PM (from 21.11.2019, 08.09.2020) and samples of USED PM: See a very slight darkening of used PM, which indicates a workload (PM were at a workload of 197 km / 292 days from approximately 21.11.2019 to 08.09. 2020). PMs are clear and visually show no signs of sedimentation-separation of solid particles.

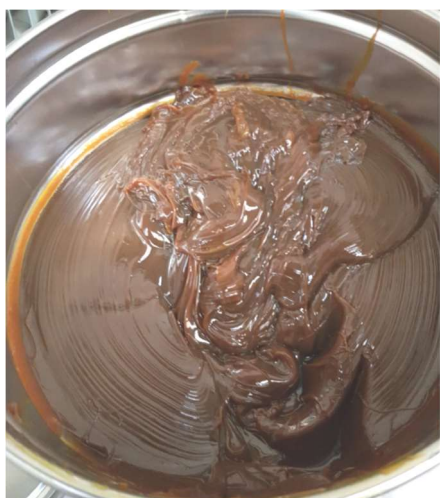
Visualization of PM Total Ceran, NLGI 0, UNUSED, BEFORE the first test filling into PSU:

**Fig. 12** PM Total Ceran, NLGI 0, NEW  
Source: authors.

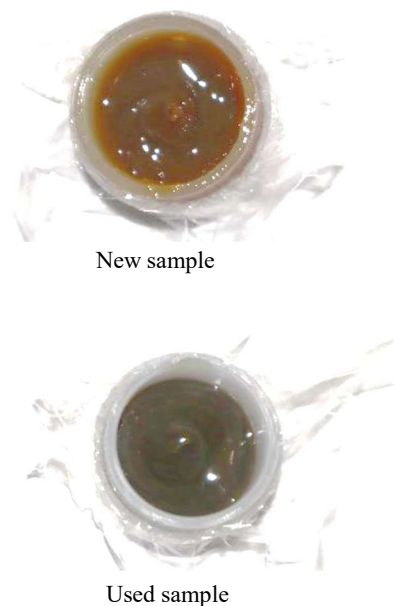
Comparison of samples of UNUSED PM and samples of USED PM: See a very slight darkening of used PM, which indicates a workload (PM was at a workload of 197 km / 292 days approximately from 21.11.2019 to 08.09.2020). PM is clear and visually shows no signs of sedimentation / separation of solid particles.

In view of this PM Total Ceran AD Plus test, NLGI 0 SUITABLE for further use.

**Fig. 13** PM Total Ceran, NLGI 0  
Comparison of Reference and used sample  
Source: authors.
